UNIVERSITÄT SIEGEN

BACHELORARBEIT

**Dealing with core column issues on ITkPix modules for the  
HL-LHC upgrade of the ATLAS detector**

**Luke Hammer**

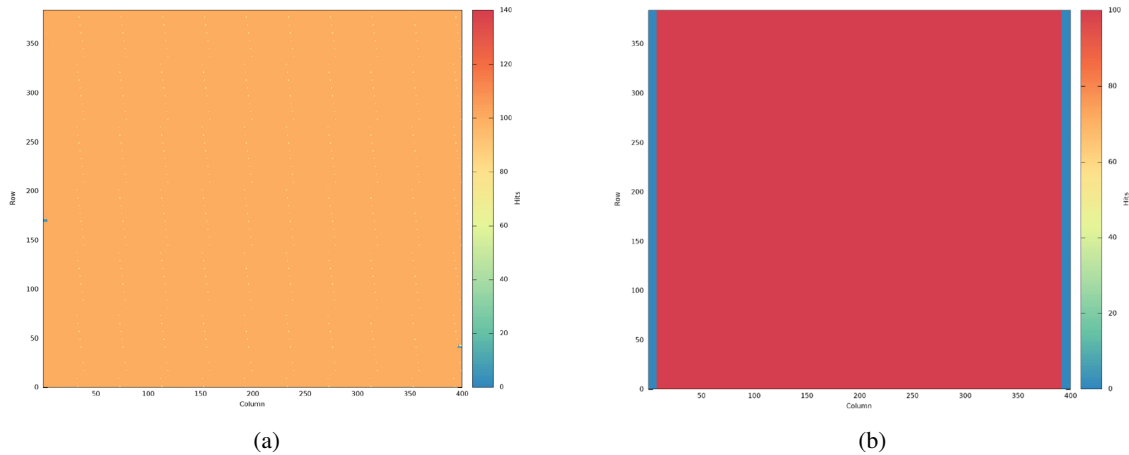
One observation during the electrical testing of pixel modules is that data loops time out during scans [10]. The extreme case of this observation is the chip's trigger processing logic entering a deadlock, in which scans are not able to finish and time out. This symptom occurs in various scan types and is difficult to distinguish from general communication failures unrelated to core column issues. If the readout is timing out or scans are not finishing, the operator has to identify whether this is caused by problematic core columns. A stuck readout could indicate a failure in the token-passing mechanism or the shared readout bus [13]. The second observation is the continuous transmission of so-called rubbish data [10]. During electrical testing, the DCB gets continuously flooded with this rubbish data. This results in unpredictable hit patterns on the affected chip occupancy maps during electrical testing. An example is given in Figure 3.1, where two digital-scan occupancy maps are shown for one chip 0x207c9 of module Si021. In a digital scan, 100 test pulses are injected into the digital logic of the FE chips for each individual pixel. It is an efficient check of whether the token-passing mechanism and the digital logic are working as intended. The expected value for a perfectly working chip is exactly 100 hits per pixel. In Figure 3.1(a), most pixels are read out with 100 hits. However, there is also a pattern on this occupancy map, as well as two small pixel clusters on the left and right chip edges. Those two pixel clusters consist of potentially broken or noisy pixels. This

already hints at a possible defect in the corresponding readout buses in these specific core columns. In Figure 3.1(b), similar scan results are displayed, but now the outer two core columns have been disabled in the chip configuration file. After masking those core columns, the rest of the chip no longer shows an unexpected pattern, and all pixels receive the intended 100 hits. Such behaviour can happen, for example, if the core column bus is damaged, which can have multiple causes, such as mechanical damage or a defect in the electronics of the readout chip.

Figure 3.1: Digital-scan occupancy maps for chip 0x207c9 of module Si021. The occupancy map in (a) is an example of a core column issue symptom: the transmission of so-called rubbish data. Panel (b) illustrates how masking problematic core columns can eliminate readout congestion and recover overall chip operation.

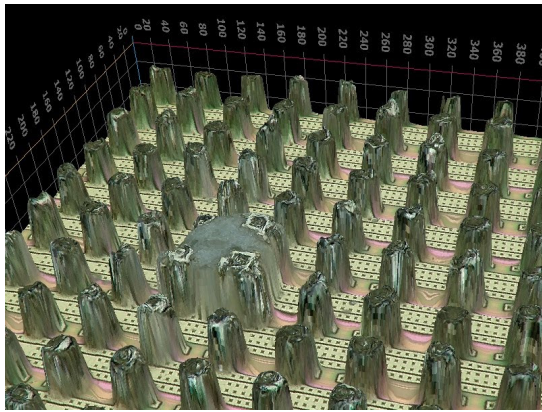
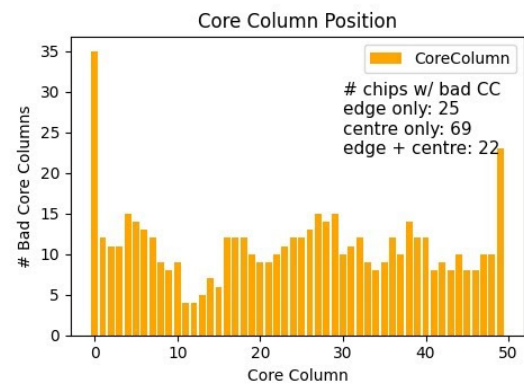
Design flaws as an origin of core column issues are considered unlikely. There are no intrinsic issues with the RD53 FE chip design because the affected chips were classified as fully functional during wafer probing [10]. Evidence suggests the core column issue originates during the post-wafer processing stages, specifically dicing and flip-chip bump-bonding. Affected modules have been disassembled, and silicon shards or other debris have been found at locations corresponding to disabled core columns. An example of a silicon shard located between multiple bump bonds after disassembly of a bare module is displayed in Figure 3.3(a). This silicon shard corresponds to a disabled core column in electrical testing and is most likely causing this core column issue. The distribution of the core column positions in Figure 3.3(b) shows that disabled core columns are more likely to occur at chip edges than elsewhere in the chip. This might be related to mechanical damage induced during dicing at the hybridisation vendors. In addition, microscopic cracks in the silicon of the FE chip have been observed that are related to core column issues. Currently, mechanical damage is considered the most likely cause of core column issues. This damage can be introduced at the hybridisation vendor during flip-chip bump-bonding or dicing. However, this can also happen because of damage during handling at other institutes, since the bare module, especially the thin silicon sensor, is fragile.

Figure 3.3: In panel (a), a pixel module was disassembled, and debris was found between multiple bump bonds. This debris was found at a position corresponding to a disabled core column in the pixel matrix. The histogram in (b) displays the distribution of the positions of the core columns that were masked during electrical testing. Figure adapted from [10].

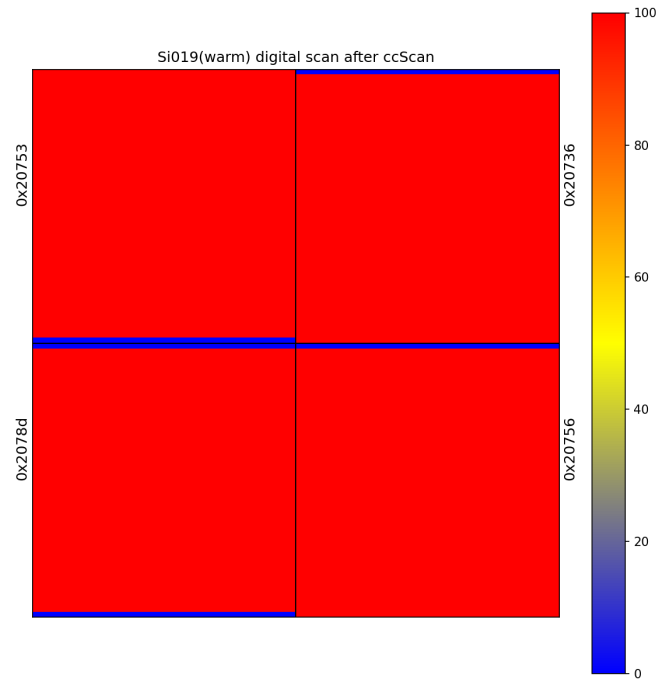
Figure 4.2: Digital-scan occupancy maps of module Si019 after a core column scan.

Therefore, the GUI tool for manual masking was used to provide the same core column configuration for cold which was used for warm testing. After that, module Si019 could be operated without readout issues in a full electrical test routine under cold conditions. Each of those core columns introduced readout congestion when it was re-enabled. Thus, this is the core column configuration that provides stable module operation and cannot be reduced further. In the cold testing regime, almost all tests passed the given QC criteria. The failing tests are clearly not core-column-related, such as the IREF (reference current) checks included in the so-called analog readback test. Module Si019 showed five affected core columns, and after masking them with the given tools, the module could be operated as usual.

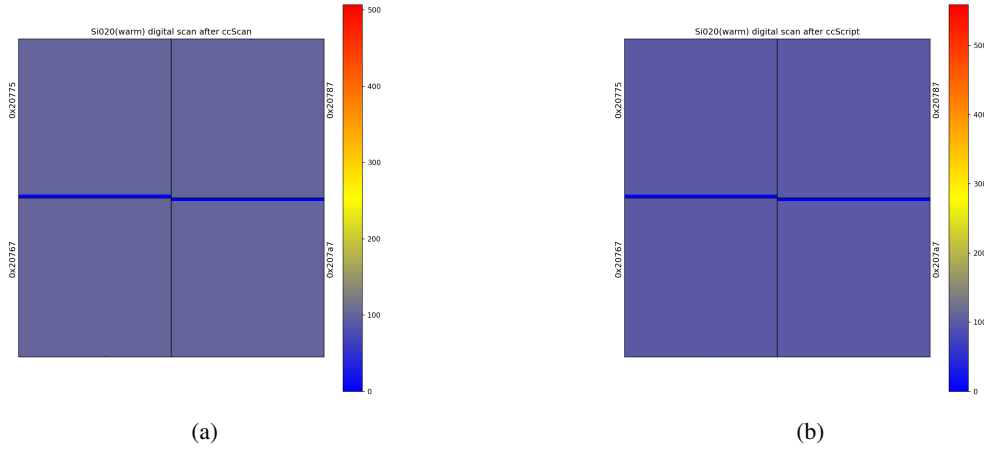
For the second module, Si020, a communication check was performed. The core column scan disabled core column 50 on chips 1 (0x20775) and 3 (0x207a7). After that, a few noisy and broken pixels were observed in the digital scan on the outer edges of the other two chips. During electrical testing, readout errors still occurred. The next step was to use the core column script to identify more core columns that caused those issues. The core column script did not mask any additional core columns in this case. The occupancy maps of the digital scans after the core column scan and the core column script are shown in Figure 4.3. The next step was to mask the core columns corresponding to the suspicious pixels in the digital scans manually. The GUI tool was used to disable core column 50 on chips 2 (0x20767) and 4 (0x20787). A plot of the digital scan after manual masking is displayed in Figure 4.4. All pixels outside the disabled core columns recorded the expected 100 hits. After that, the module could be operated without readout congestion. Module Si020 showed no difference in behaviour under warm and cold conditions. The module now passes all electrical tests except the IV scan, which is not related to core column issues. The IV scan measures the leakage current as a function of the applied high voltage.

Figure 4.3: Plot (a) shows the digital-scan occupancy map of module Si020 after a core column scan. In plot (b), the digital-scan occupancy map of module Si020 after use of the core column script is displayed.

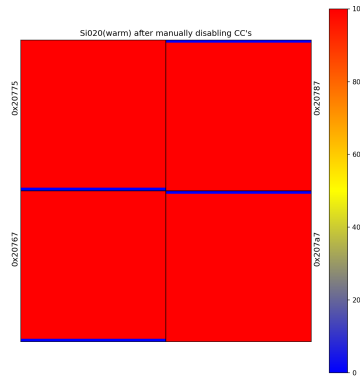
Figure 4.4: This plot shows the digital-scan occupancy maps of module Si020 after manual masking of core columns using the GUI tool.

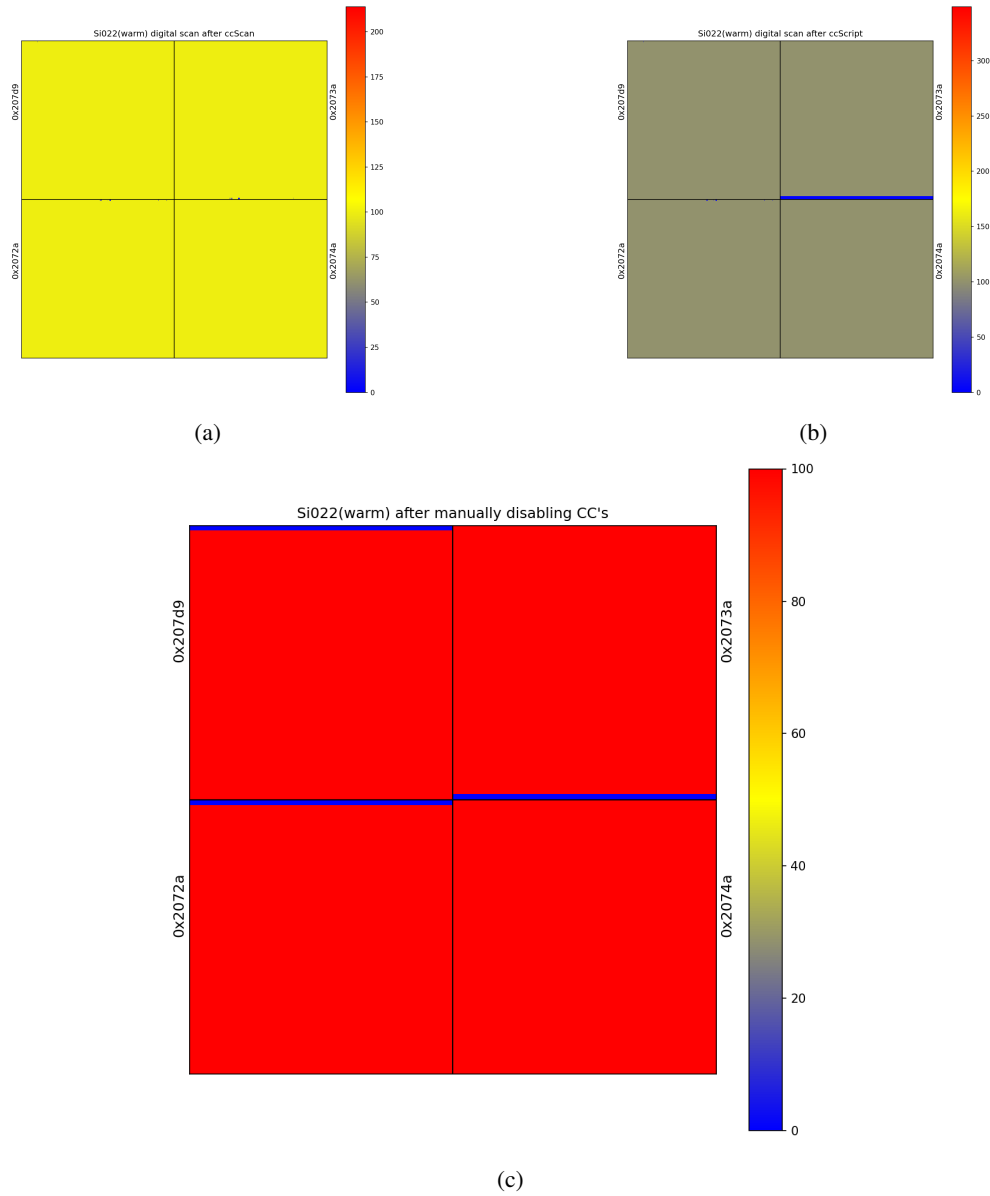
The last module with an ITkPix v2 chip that was investigated in detail was module Si022. After the initial communication check, no core columns were masked automatically. In the digital-scan occupancy map shown in Figure 4.5(a), suspicious pixels were observed on chip 2 (0x2072a) and chip 4 (0x2073a). After running the core column script, core column 1 on chip 4 (0x2073a), which contained several suspicious pixels, was masked automatically. This is displayed in Figure 4.5(b). Module Si022 still showed readout issues during electrical testing, so the GUI tool was used to mask the additional core column 1 on chip 2 (0x2072a). This cleared the readout congestion during electrical testing. With this configuration, the module successfully went through a full electrical test routine under warm and cold conditions.

Figure 4.5: Digital-scan occupancy maps of module Si022 after different stages of the recovery procedure. (a) After the core column scan. (b) After the core column script. (c) After manual masking using the GUI tool.

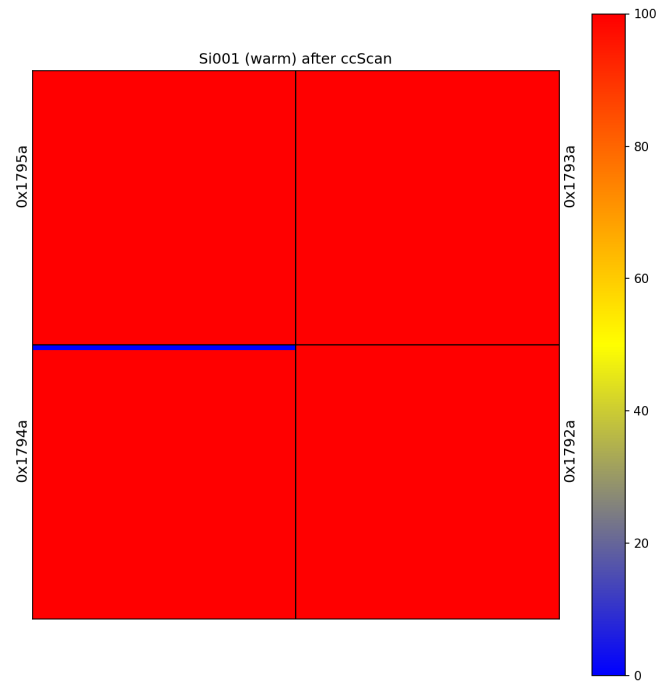
Module Si001 was the first ITk pixel module assembled in Siegen. The bare module was rotated relative to the flexible PCB during assembly. Because of that, the module could only be biased at 5 V instead of the intended 120 V. Because of the rotation of the components, the wire bonds touch each other and the silicon sensor. This causes a short circuit and limits the bias voltage. After the initial communication check, core column 1 on chip 2 (0x1794a) was disabled automatically. The digital-scan occupancy map is displayed in Figure 4.6. No additional manual masking was necessary. Module Si001 could be operated stably without readout issues occurring. Due to the assembly issue, the rotation of components relative to each other, the IV scan failed as expected. Apart from that, the analog readback test also failed because of the IREF checks, while the data merging test, which is not applicable to ITkPix v1.1 modules, is expected to fail.

Figure 4.6: This plot shows the digital-scan occupancy map of module Si001 after a core column scan.

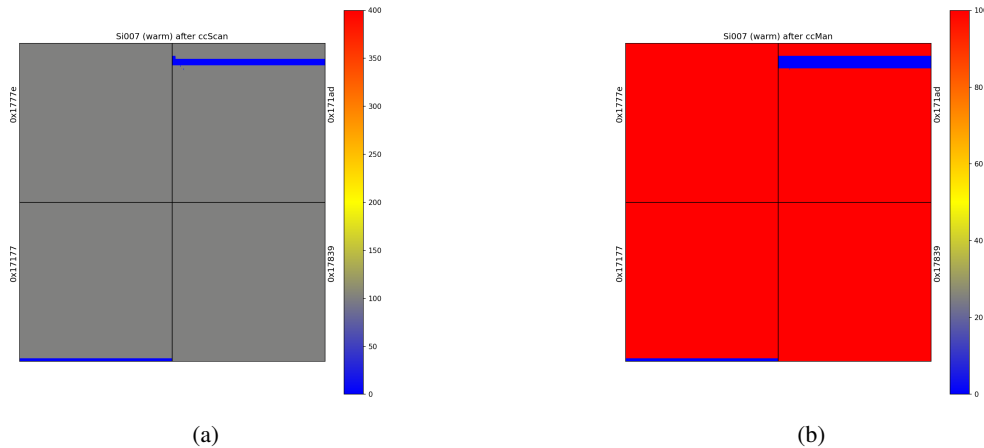
The next investigated module was Si007. The core column scan was able to mask core column 50 on chip 2 (0x17177) and core columns 44 and 45 on chip 4 (0x171ad). The corresponding digital-scan occupancy map is shown in Figure 4.7(a). Above the two disabled core columns on chip 4 (0x171ad) is a block of pixels that receive zero hits. Below those two core columns are multiple pixels that are noisy or broken. Module Si007 showed readout issues during electrical testing with this core column configuration. The core column script did not mask any additional core columns. Because of that, the GUI tool was used again to find a configuration through manual masking. The core column configuration after manual masking ensured stable module operation and eliminated further readout

issues. This configuration is illustrated in Figure 4.7(b). Module Si007 passes QC criteria for electrical tests except for the YARR scans. Those include a minimum health test, a tuning procedure, and a full pixel failure analysis, including a source scan. Because more than two core columns are masked on one chip, their analyses fail automatically; only two disabled core columns per chip are allowed. As for Si001, this module fails the IREF checks, while the data merging test is not applicable to ITkPix v1.1 modules and is therefore expected to fail.

Figure 4.7: Plot (a) shows the digital-scan occupancy map of module Si007 after a core column scan. In plot (b), the digital-scan occupancy map of module Si007 after manual masking of core columns is displayed.

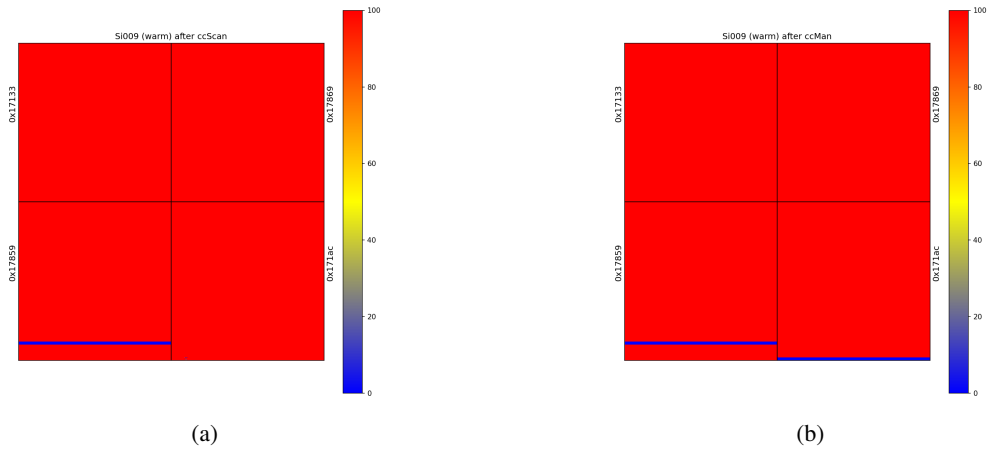
Module Si009 had one masked core column 45 on chip 2 (0x17859) after the initial core column scan inside the communication check. As displayed in Figure 4.8(a), some suspicious pixels are observed at the bottom edge of chip 3 (0x171ac). The module showed readout issues, which were resolved after manual masking of the corresponding core column 1 on chip 3 (0x171ac) with the GUI tool. The digital-scan occupancy map after manual masking is shown in Figure 4.8(b). The module failed only IREF checks and data merging again; otherwise, all QC criteria were satisfied and stable operation is ensured.

Figure 4.8: Plot (a) shows the digital-scan occupancy map of module Si009 after a core column scan. In plot (b), the digital-scan occupancy map of module Si009 after manual masking of core columns is displayed.

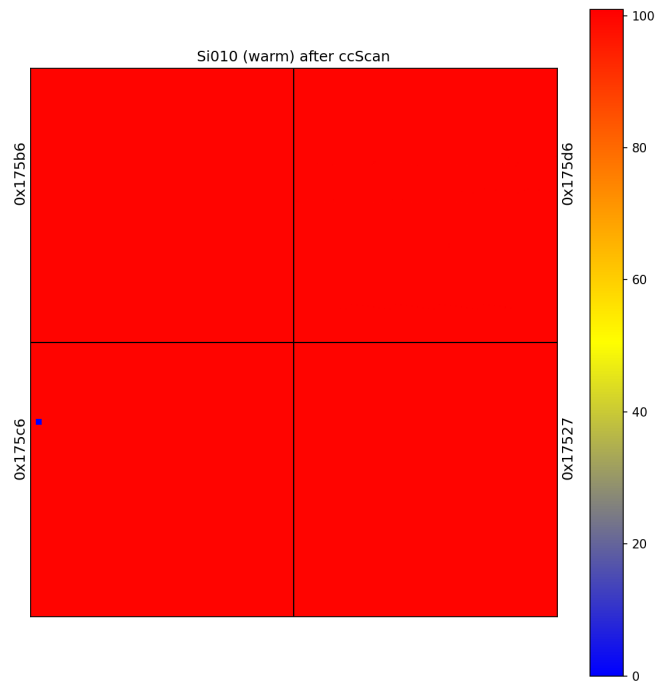
The next module in this investigation, Si010, had previously failed several electrical tests, with all four chips enabled. It was not possible to find a core column configuration to improve the test results of this module. A digital-scan occupancy map is displayed in Figure 4.9, where a block of pixels receives zero hits. Masking the corresponding core column did not improve electrical testing stability. The search for another working core column configuration was also unsuccessful. Therefore, the investigation for this module was discontinued.

Figure 4.9: This plot shows the digital-scan occupancy maps of module Si010 after a core column scan.

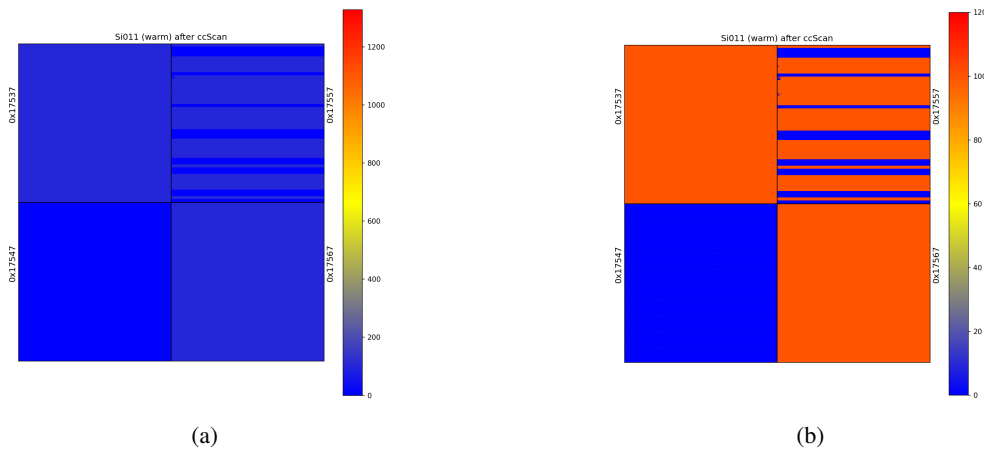
At the beginning of the investigation of module Si011, both types of core column symptoms occurred. The digital-scan occupancy map after the initial core column scan is displayed in Figure 4.10. In Figure 4.10(a), a few pixels were very noisy, making the plot unsuitable to search for more core column issues. To identify more problematic areas, an upper display limit was set to 120 hits, and every pixel exceeding this ceiling was set to exactly 120 hits. The result is shown in Figure 4.10(b). The core column scan disabled 15 core columns (1, 3, 4, 10, 11, 13, 14, 21, 22, 23, 31, 41, 47, 48, and 49) on chip 4 (0x17557). On the other three chips, no core columns were masked automatically. A pattern of rubbish data was observed on chip 2 (0x17547), which is likely caused by more core column issues. The core column script was not useful here; it completely disabled chip 2 (0x17547).

Figure 4.10: Plot (a) shows the digital-scan occupancy map of module Si011 after a core column scan. In plot (b), the same data are shown, but now every pixel with more than 120 hits is set to exactly 120 hits.

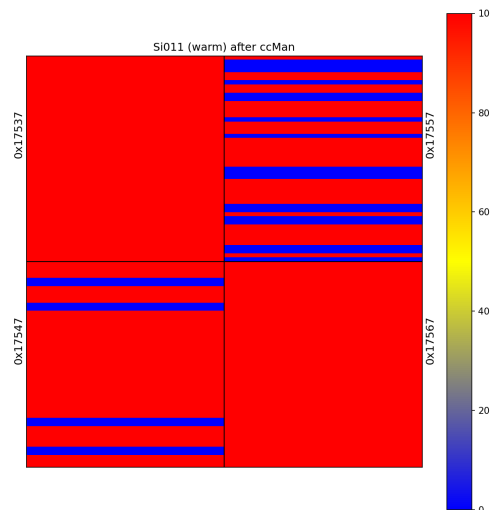
Additional masking had to be done with the GUI tool. As there was no suspicious cluster of pixels on chip 2 (0x17547), different subsets of core columns were enabled and disabled until a minimal core column configuration was found to ensure stable communication with module Si011. The masked core columns were core columns 5, 6, 11, 12, 39, 40, 46, and 47 on chip 2 (0x17547) and core columns 35, 40, and 44 on chip 4 (0x17557). This configuration is displayed in Figure 4.11. It is not clear why so many core columns were problematic. No external damage was observed, but some internal circuitry may have been damaged. This may have happened because of debris between bump bonds or internal damage due to mechanical stress. This example shows that even modules with severe issues can be configured to ensure stable operation during electrical testing. This module did not pass the IREF check and failed all YARR scans as expected because of too many disabled core columns per chip.

Figure 4.11: This plot shows the digital-scan occupancy maps of module Si011 after manual masking of core columns with the GUI tool.

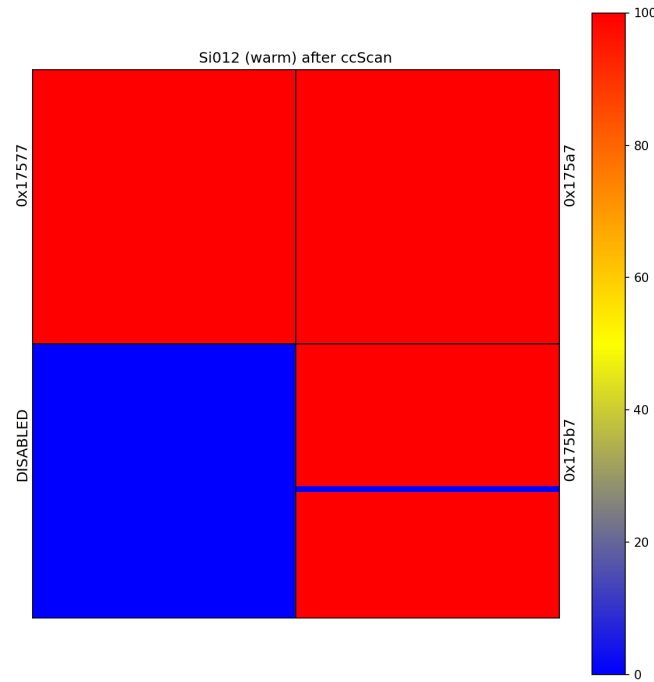
The last investigated module in this study was Si012. Chip 2 (0x17587) was unresponsive during electrical testing. It did not show a signal in the eye diagram, which typically indicates that this chip is not recoverable. No core column configuration was found to resolve this issue, and the chip had to be disabled entirely again. The core column scan disabled core column 24 on chip 3 (0x175b7) automatically. After that, the three enabled chips could be operated stably. The digital-scan occupancy map of module Si012 is displayed in Figure 4.12. With this configuration, the module was successfully tested using the three enabled chips. A full electrical test routine passed all QC criteria except data merging, which is expected for ITkPix v1.1 modules.

Figure 4.12: This plot shows the digital-scan occupancy maps of module Si012 after a core column scan.

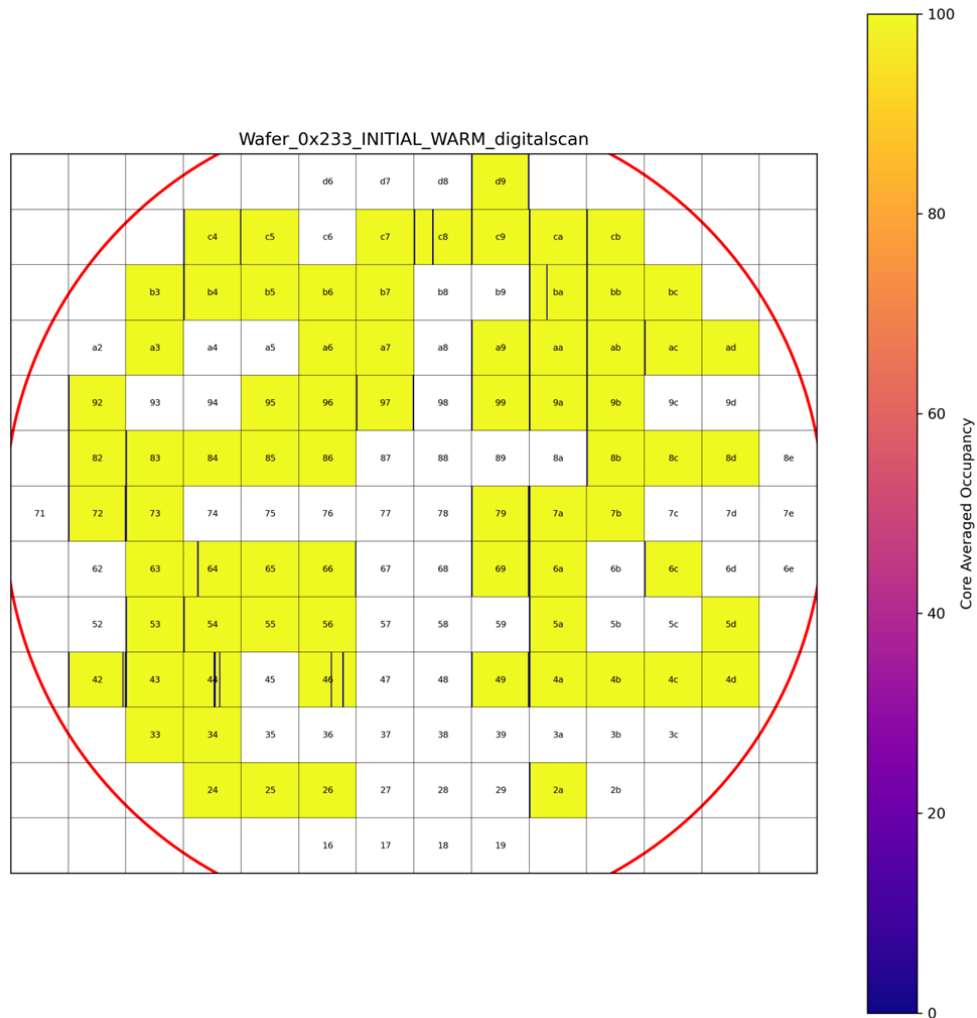
Most core column issues in Siegen have been observed at chip edges. This is consistent with the observation of L. Meng et al. [10]. To further investigate its possible connection to the dicing procedure used by hybridisation vendors, custom wafer plots were created. Most of the bare modules used for assembly in Siegen are provided by Fraunhofer IZM. To check whether disabled core columns at chip edges were adjacent on the original wafer, a custom plotting script was used to create wafer plots with the digital-scan occupancy maps of the chips. The largest group comprises 72 out of 132 chips and originated from wafer 0x233. The wafer plot is displayed in Figure 4.13. The plot clearly shows that many disabled core columns occur at adjacent chip edges. This observation supports the hypothesis that the dicing procedure used at IZM may damage the chip edges. IZM therefore introduced a new method. Laser pre-grooving is now used before the actual dicing to produce cleaner chip edges and to reduce edge defects that may lead to core column issues. Another wafer, 0x252, has been investigated to check whether the new method improves the chip quality. The wafer plot for 0x252 is shown in Figure 4.14. Of the 38 chips, only one chip was affected by a core column issue, which is located in the middle of the chip and not at the edge. Laser pre-grooving appears to improve the dicing quality of IZM significantly. This result is also visible in core column statistics for all modules built in Siegen. They are presented in Chapter 4.7.

Figure 4.13: Distribution of core columns on wafer 0x233 using digital-scan occupancy maps of the chips.

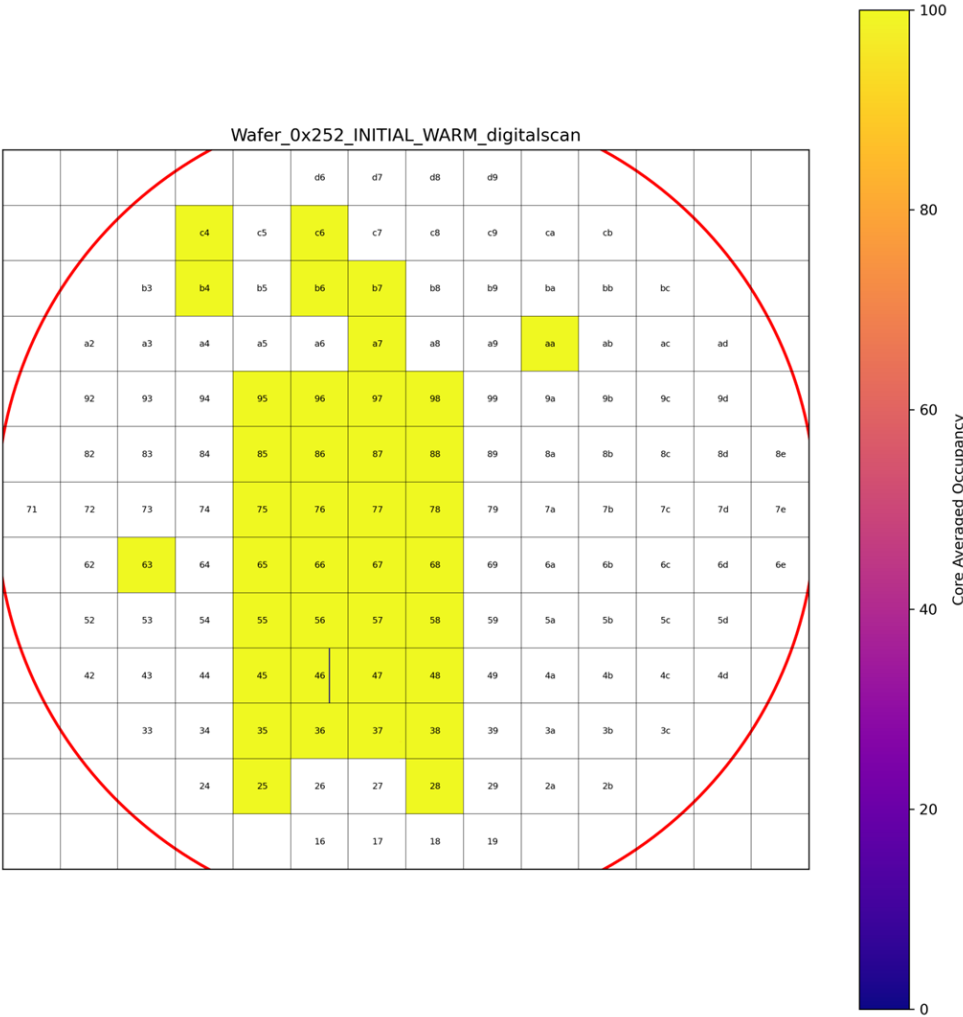
Figure 4.14: Distribution of core columns on wafer 0x252 using digital-scan occupancy maps of the chips.

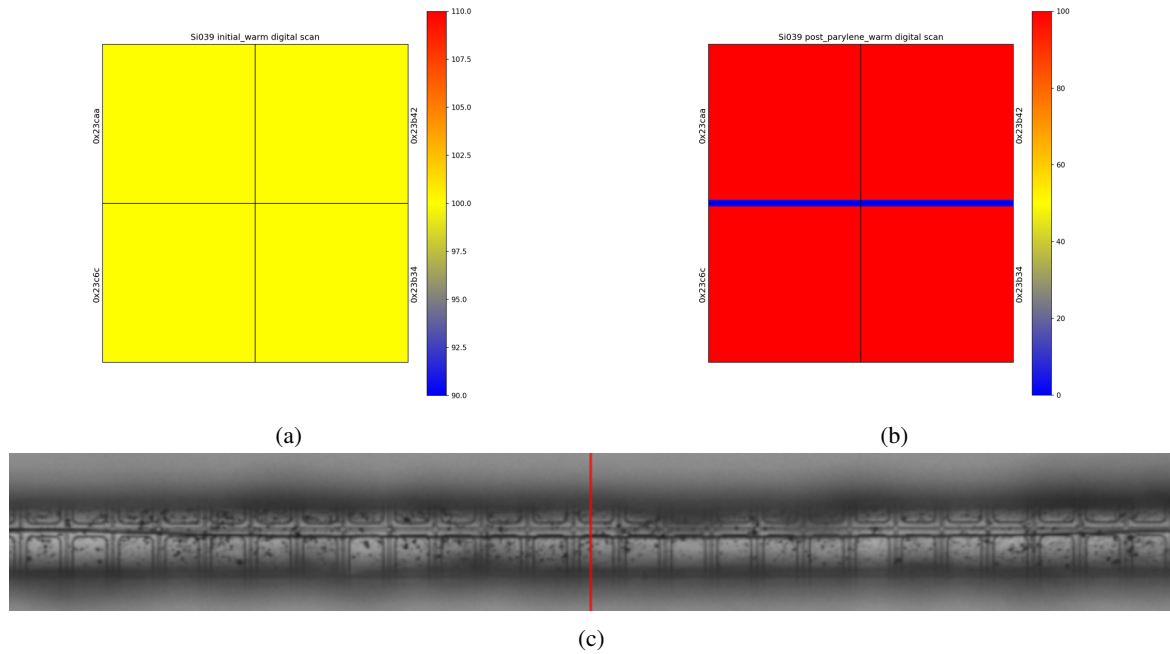
A further mechanical defect related to core column issues in this work is the so-called sensor cleavage. Because the sensor thickness is of the order of  $O(100\text{ }\mu\text{m})$ , it can easily be damaged if not handled carefully enough. An example of this is module Si039. The module operated without any indication of core column issues during initial electrical testing. After several mechanical processes, such as masking, shipping to industry for coating, parylene coating, shipping back to Siegen, and demasking, module Si039 showed four affected core columns. These core columns were all located in the inter-chip regions of the module. The occupancy maps before and after parylene coating are displayed in Figures 4.15(a) and 4.15(b). A photograph was taken of the chip side of the module. Between the chips, a small crack is visible in the sensor (see Figure 4.15(c)). This type of mechanical damage is referred to as sensor cleavage. Its position corresponds directly to the positions of the affected core columns on module Si039 after parylene coating.

Figure 4.15: Plot (a) shows the digital-scan occupancy map of module Si039 during initial electrical testing. In plot (b), the digital-scan occupancy map of module Si039 in post-parylene electrical testing is displayed. Panel (c) shows a photograph of the mechanical damage on the silicon sensor between the FE chips.
