UNIVERSITÄT SIEGEN

BACHELORARBEIT

**Dealing with core column issues on ITkPix modules for the  
HL-LHC upgrade of the ATLAS detector**

**Luke Hammer**

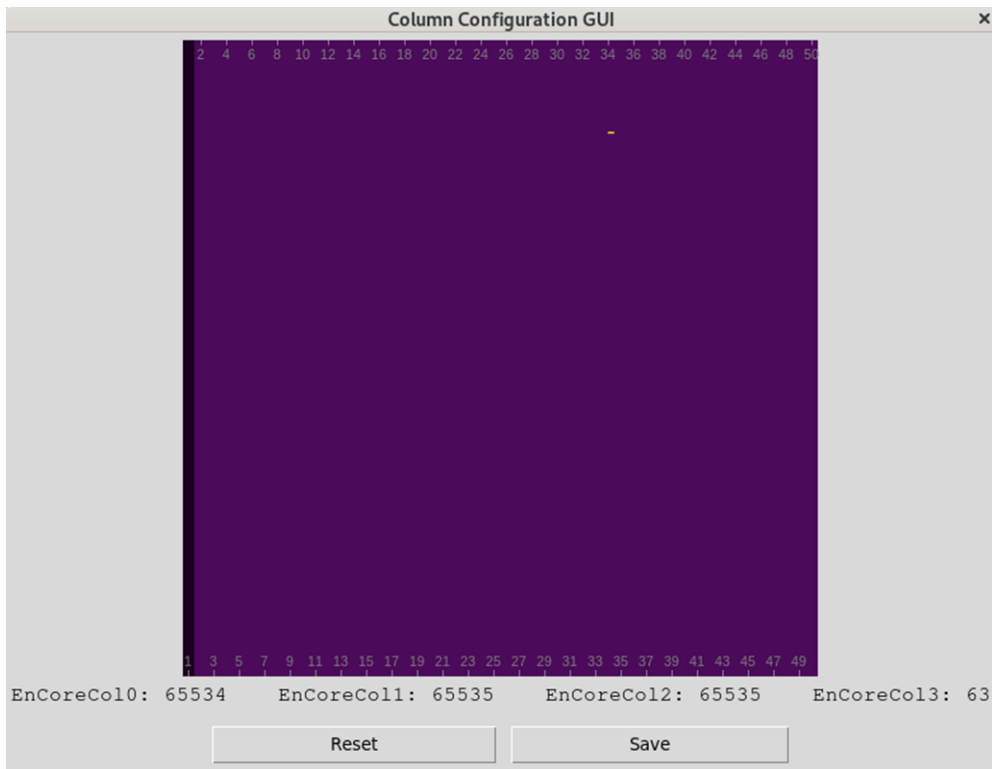
Figure 3.2: The GUI tool for manual core column masking for a single chip. The operator can view the current core column configuration or select a new set of core columns to mask manually. An occupancy map of a previous scan is displayed as a background layer to identify clusters of suspicious pixels.
